Test Report No.: CY/2012/71382 Date: 2012/07/26 Page: 1 of 3

Sample Description : BREAST PUMP TUBING

Overall migration test of plastic material and articles

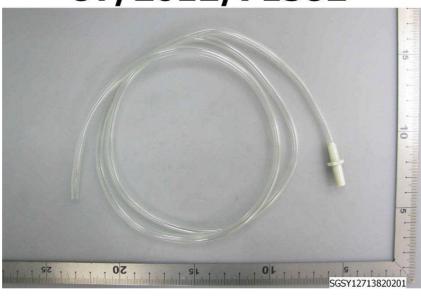
CY/2012/71382

* The tested sample / part is marked by an arrow if it's shown on the photo. *

PART NAME No.1 : MIXED GRAY PLASTIC AND TRANSPARENT PLASTIC TUBE
