Test Report

Number : TWNC01014021

One (1) Group of Submitte	d Samples Said To Be :
Item Name	: Breast Pump Parts_Diaphragm,Duckbill,Pad
Item No.	: PP012-D,PP012-U,PP012-P
Manufacturer	: Maymom LLC
Buyer	: Maymom LLC
Country of Origin	: Taiwan
Goods Exported To	: USA,UK,CA,China,DE,AU,FR,IT,ES,AU,SG
Remark	: The batch No. of PP012-D,PP012-U,PP012-P is R20210722-5.
Date Sample Received	: Aug 25, 2021
Date Test Started	: Aug 26, 2021

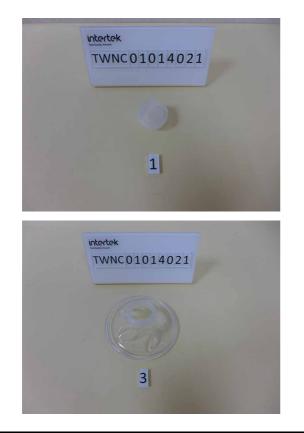
Sample photo:

- (1) Semitransparent plastic part
- (2) Semitransparent plastic part
- (3) Semitransparent plastic part
